Inspection Report

Property Address:
25329 145th Pl SE
Kent WA 98042

Sound Home Inspections Inc.

Date: 4/8/2018	Time: 10:40 AM	Report ID: 10720AQ030
Property: 25329 145th Pl SE Kent WA 98042	Customer: Martin Wise	Real Estate Professional: Aaron Hendon Keller Williams

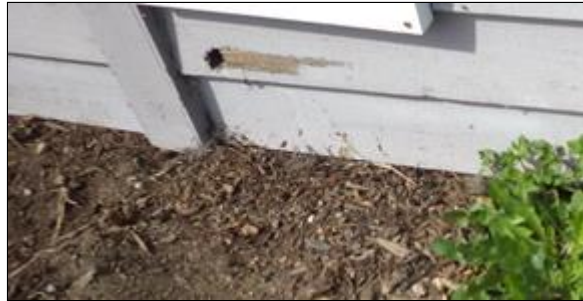
1.0 Item 1(Picture) Example

(4) Wood to soil contact (when deteriorated can lead to pests) at the front and left side (facing front) of the building. Soil separation of 4-6" is recommended to prevent deterioration.

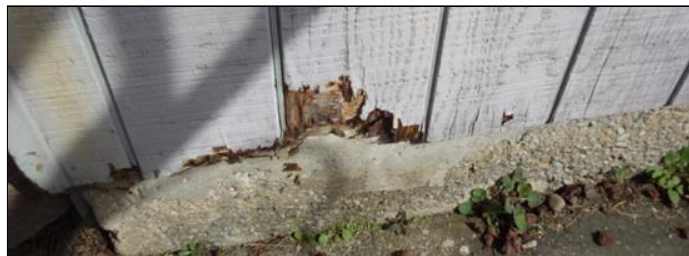
1.2 Item 2(Picture) Example

- 🔧 (4) The paint on much of the siding is old and is failing. The painting the house will help protect the siding from the elements. I recommend having a qualified painter perform this work.
- 🔧 (5) The siding is deteriorated on bottom edge along the front and left side (facing front) of the building. Because of the extent of deterioration it is possible for some framing to be deteriorated. A qualified person should repair or replace as needed.

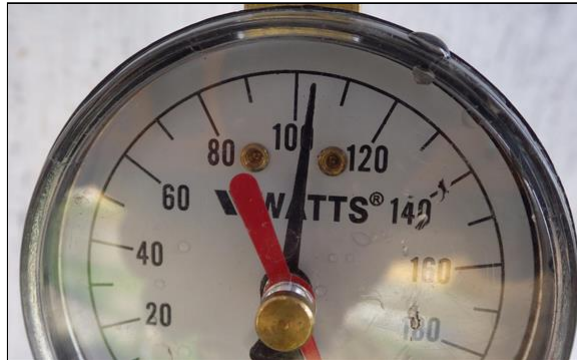
1.5 Item 1(Picture) Water pressure

(1) Water pressure tested at 105 psi on the rear of the building at the start of the inspection. Water pressure is recommended to be between 45-65 psi in most jurisdictions. Plumbing standards recommend installing/adjusting Pressure Regulator for water pressure in excess of 80 psi.

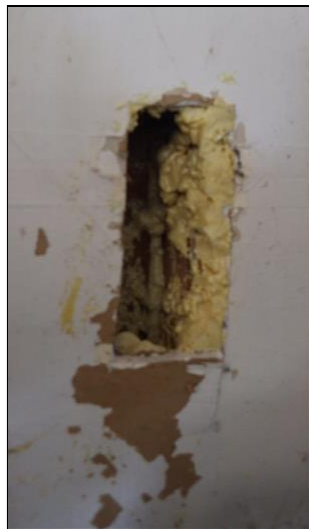
2.1 Item 1(Picture)
Example

+ Recommend penetrations at firewall be filled. 5/8" wallboard is recommended for firewall between living spaces. Drywall should be mudded and tapped for added fire protection. Fire putty is recommended for protrusions extending into attic space. Check with local building codes for variations of requirements.

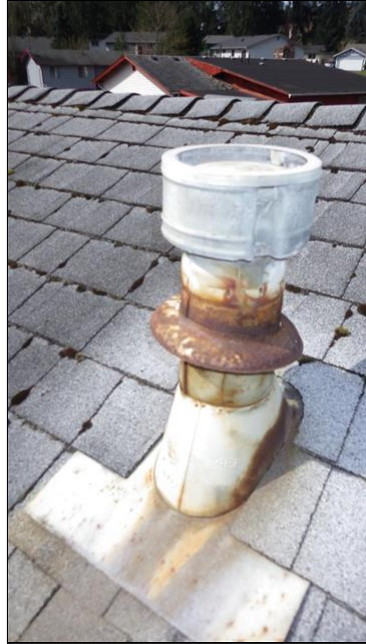
3.2 Item 1(Picture)
Example

(3) The B-vent for the gas appliances is rusted above the roof line. Replacement of the exterior portion of this will be necessary as point in the future. This is for your information.

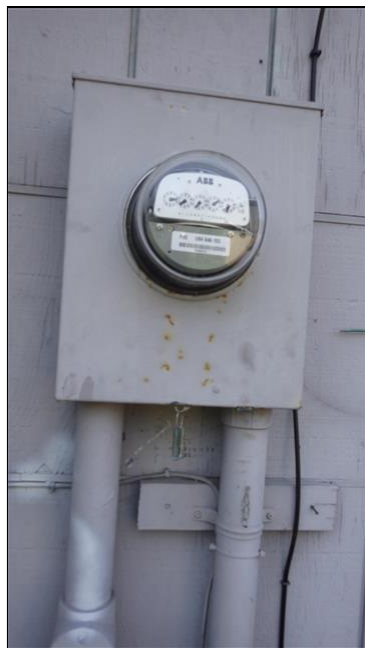
4.0 Item 1(Picture)
Electrical Meter

The electrical meter is located at the right side (facing front) of the building. The main panel box is located at the downstairs living room . The main disconnect is located at the panel.

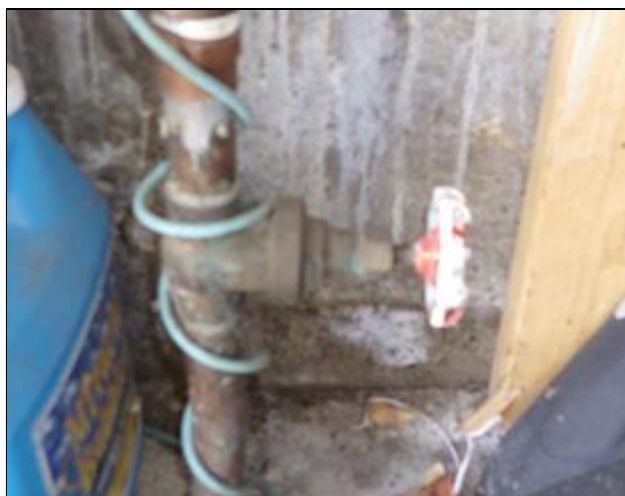
5.0 Item 1(Picture) Water shutoff

The water meter was not located. The main shut off is the red and white knob located in the garage. This is for your information.

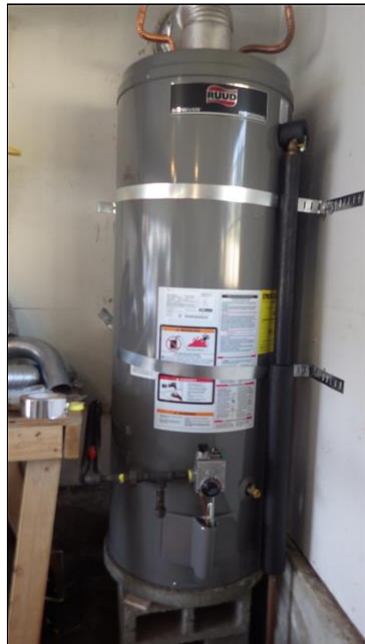
5.3 Item 1(Picture) Water heater

(1) The water heater is located in the garage. Model/Serial #'s are provided if accessible/legible and for your information only. Recommend installing water alarm at base of water heater.

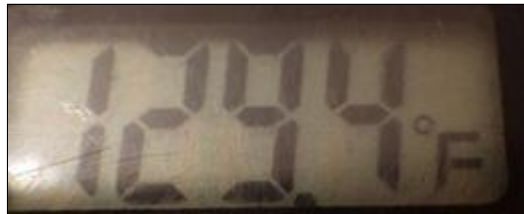
5.3 Item 3(Picture) Water temperature

NOTE: Tank temperatures should be no less than 130 degrees F to prevent bacterial growth, such as Legionnaires disease. The temperature of the water at the water heater will generally be higher than the temperature coming out of the tap.

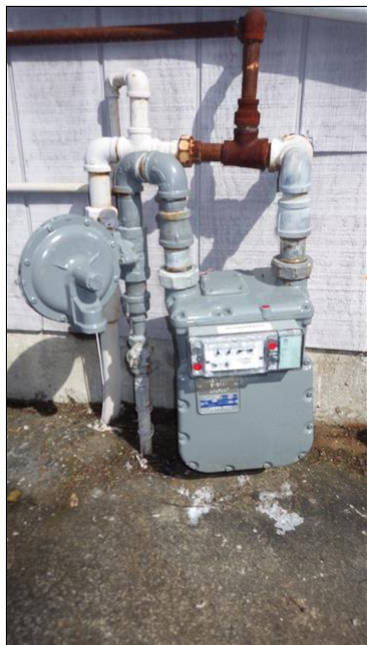
5.4 Item 1(Picture) Gas Meter

The main fuel shut off is at gas meter at the left side (facing front) of the building. Recommend hanging a wrench or discussing with neighbors an emergency action plan.

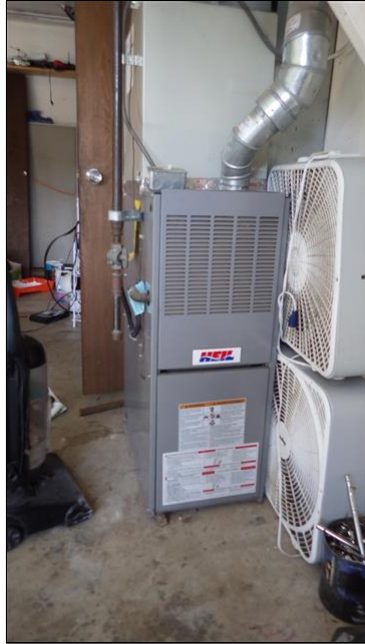
6.0 Item 1(Picture) Air Handler

(1) The furnace is located in the garage. Model/Serial numbers are supplied so that client can research any product recalls or defects. Recall information is not provided as a part of this inspection. Recommend servicing gas appliances a minimum of every 2 years or per manufacturers recommendations. Recommend installing water alarm at base of high efficiency furnaces.

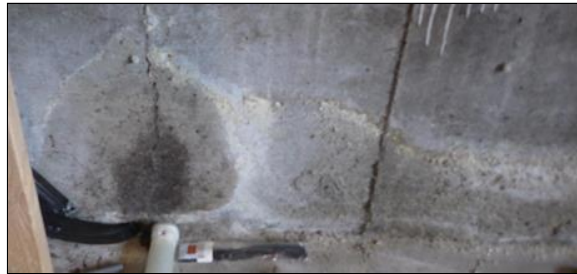
7.0 Item 1(Picture) Example

- (1) The corner of the foundation located at the left side of the garage has concrete spalling. This does not appear to be a significant structural issue at this time. I recommend monitoring this area and repairing if necessary.
- (2) White efflorescence (powder substance) on the garage foundation wall indicates moisture is in contact with the masonry. This does not necessarily indicate that intrusion will occur. I recommend checking the gutters and the downspout drain lines for proper operation. Efflorescence is found on many homes without water intrusion occurring inside the home. But, it should alert you to the possibility that future steps may be needed.

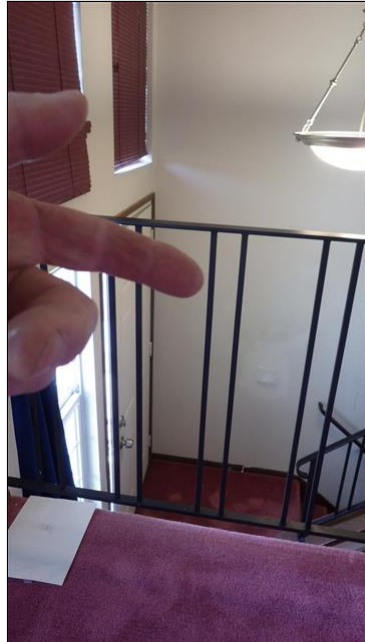
9.3 Item 1(Picture)
Example

+ A guardrail at the upper level for the stairway has openings that are greater than 4 inches. Openings that are greater than 4 inches can allow a child or pet to fall through. A fall or injury can occur if not repaired. I recommend repair by a qualified person.

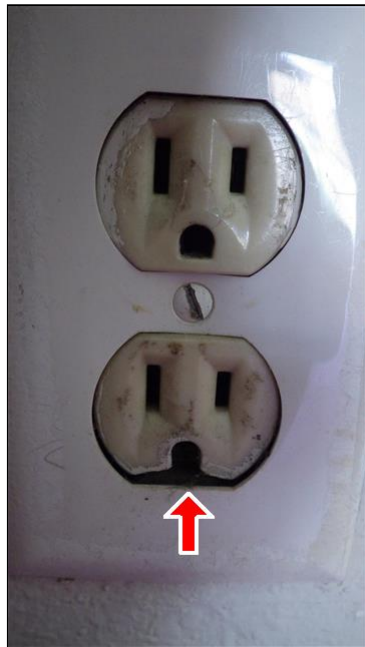
9.6 Item 1(Picture)
Example

+ (3) At least one "three-prong" outlet is loose in wall in the master bedroom. Electrical issues are considered a hazard until repaired. A qualified licensed electrical contractor should perform repairs that involve wiring.

+ (4) Several "three-prong" outlets are broken or damaged in most if not all rooms. Electrical issues are considered a hazard until repaired. A qualified licensed electrical contractor should perform repairs that involve wiring.

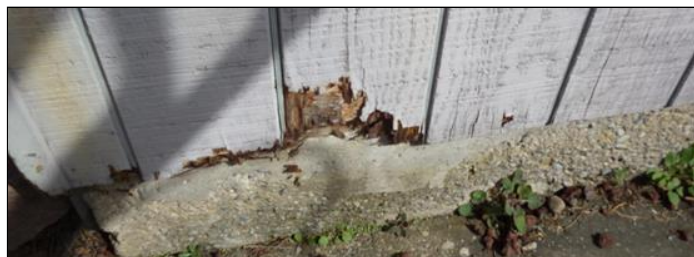
1.2 Item 2(Picture) Example

(5) The siding is deteriorated on bottom edge along the front and left side (facing front) of the building. Because of the extent of deterioration it is possible for some framing to be deteriorated. A qualified person should repair or replace as needed.

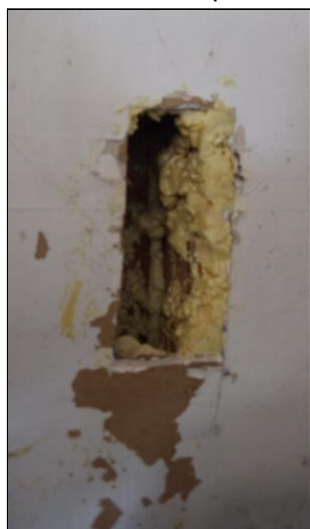
2.1 Item 1(Picture)
Example

- Recommend penetrations at firewall be filled. 5/8" wallboard is recommended for firewall between living spaces. Drywall should be mudded and tapped for added fire protection. Fire putty is recommended for protrusions extending into attic space. Check with local building codes for variations of requirements.

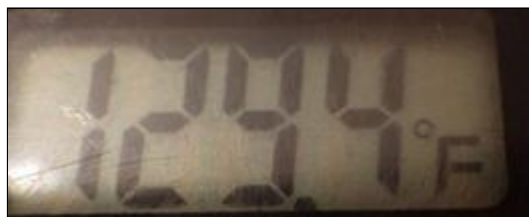
5.3 Item 3(Picture) Water temperature

NOTE: Tank temperatures should be no less than 130 degrees F to prevent bacterial growth, such as Legionnaires disease. The temperature of the water at the water heater will generally be higher than the temperature coming out of the tap.

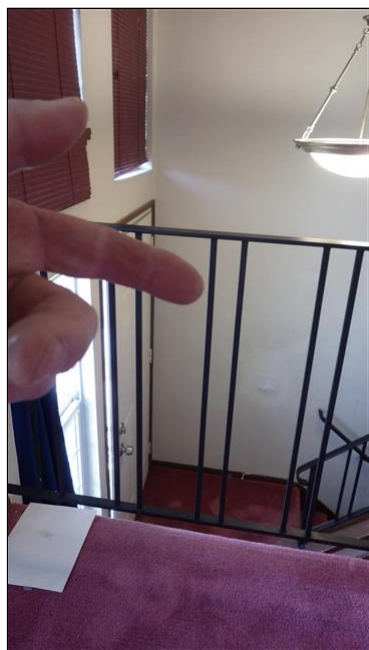
9.3 Item 1(Picture)
Example

- + A guardrail at the upper level for the stairway has openings that are greater than 4 inches. Openings that are greater than 4 inches can allow a child or pet to fall through. A fall or injury can occur if not repaired. I recommend repair by a qualified person.

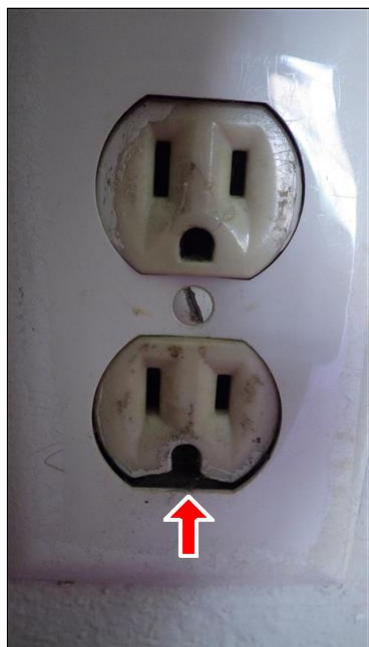
9.6 Item 1(Picture)
Example

- ⊕ (2) Missing cover plates at junction boxes in the upstairs hallway ceiling. Recommend repair.
- ⊕ (3) At least one "three-prong" outlet is loose in wall in the master bedroom. Electrical issues are considered a hazard until repaired. A qualified licensed electrical contractor should perform repairs that involve wiring.
- ⊕ (4) Several "three-prong" outlets are broken or damaged in most if not all rooms. Electrical issues are considered a hazard until repaired. A qualified licensed electrical contractor should perform repairs that involve wiring.

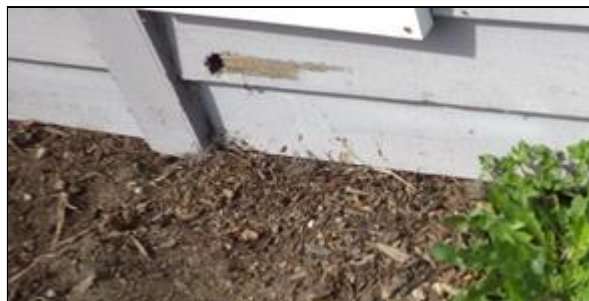
1.0 Item 1(Picture) Example

(4) Wood to soil contact (when deteriorated can lead to pests) at the front and left side (facing front) of the building. Soil separation of 4-6" is recommended to prevent deterioration.

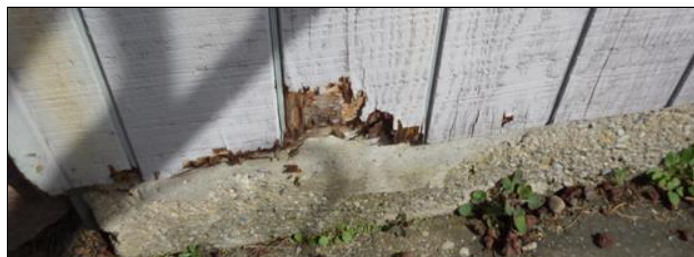
1.2 Item 2(Picture) Example

- (1) Missing/Deteriorated caulking. Recommend repair to prevent moisture intrusion.
- (2) Protrusions/Holes should be caulked/sealed to prevent moisture intrusion. Recommend repair.
- (5) The siding is deteriorated on bottom edge along the front and left side (facing front) of the building. Because of the extent of deterioration it is possible for some framing to be deteriorated. A qualified person should repair or replace as needed.

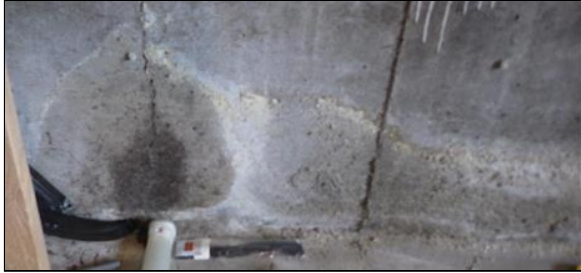
7.0 Item 1(Picture) Example

many homes without water intrusion occurring inside the home. But, it should alert you to the possibility that future steps may be needed.
