Inspection Report

Property Address:
25329 145th Pl SE
Kent WA 98042

Sound Home Inspections Inc.

Date: 4/8/2018	Time: 10:40 AM	Report ID: 10720AQ030
Property: 25329 145th Pl SE Kent WA 98042	Customer: Martin Wise	Real Estate Professional: Aaron Hendon Keller Williams

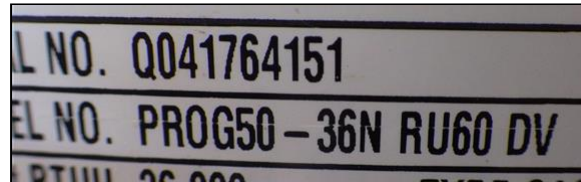
5.3 Item 2(Picture) Model/Serial #

(2) Your water heater does not have a "Thermal Expansion tank" installed to prevent a possible leak at the T&P or "pop-off" valve. Recent changes in code may require one when a new water heater is installed. This change is not retroactive on older previously installed Gas/LP water heaters such as yours. There were no leaks or drips at the T&P valve during inspection. If your water heater does begin to drip or leak, then a thermal expansion tank may be needed.

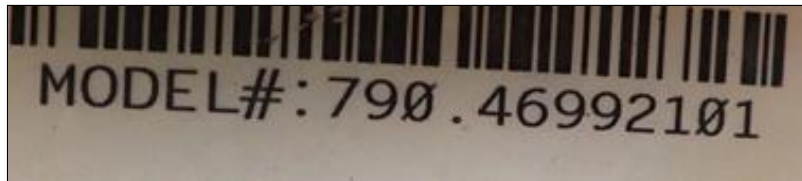
8.5 Item 1(Picture) Model/Serial #

(1) Model/Serial numbers are supplied so that client can research any product recalls or defects. Recall information is not provided as a part of this inspection.

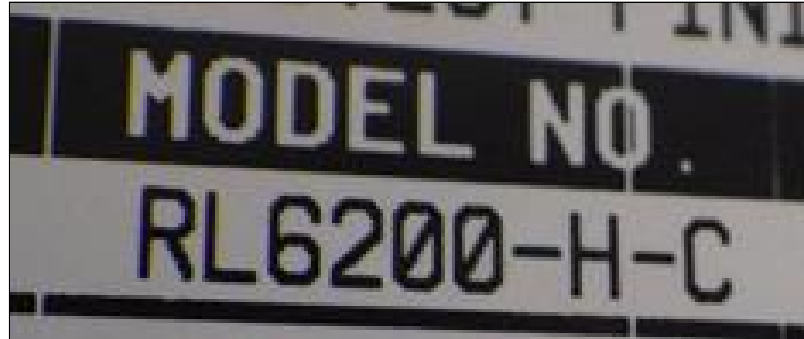
8.6 Item 1(Picture) Model/Serial #

Model/Serial numbers are supplied so that client can research any product recalls or defects. Recall information is not provided as a part of this inspection.
